PROGRESS REPORT

PR 91570-510-12

For the Period of 1 June 1964, through 30 June 1964

DEVELOPMENT OF A HYDROGEN-OXYGEN SPACE POWER SUPPLY SYSTEM

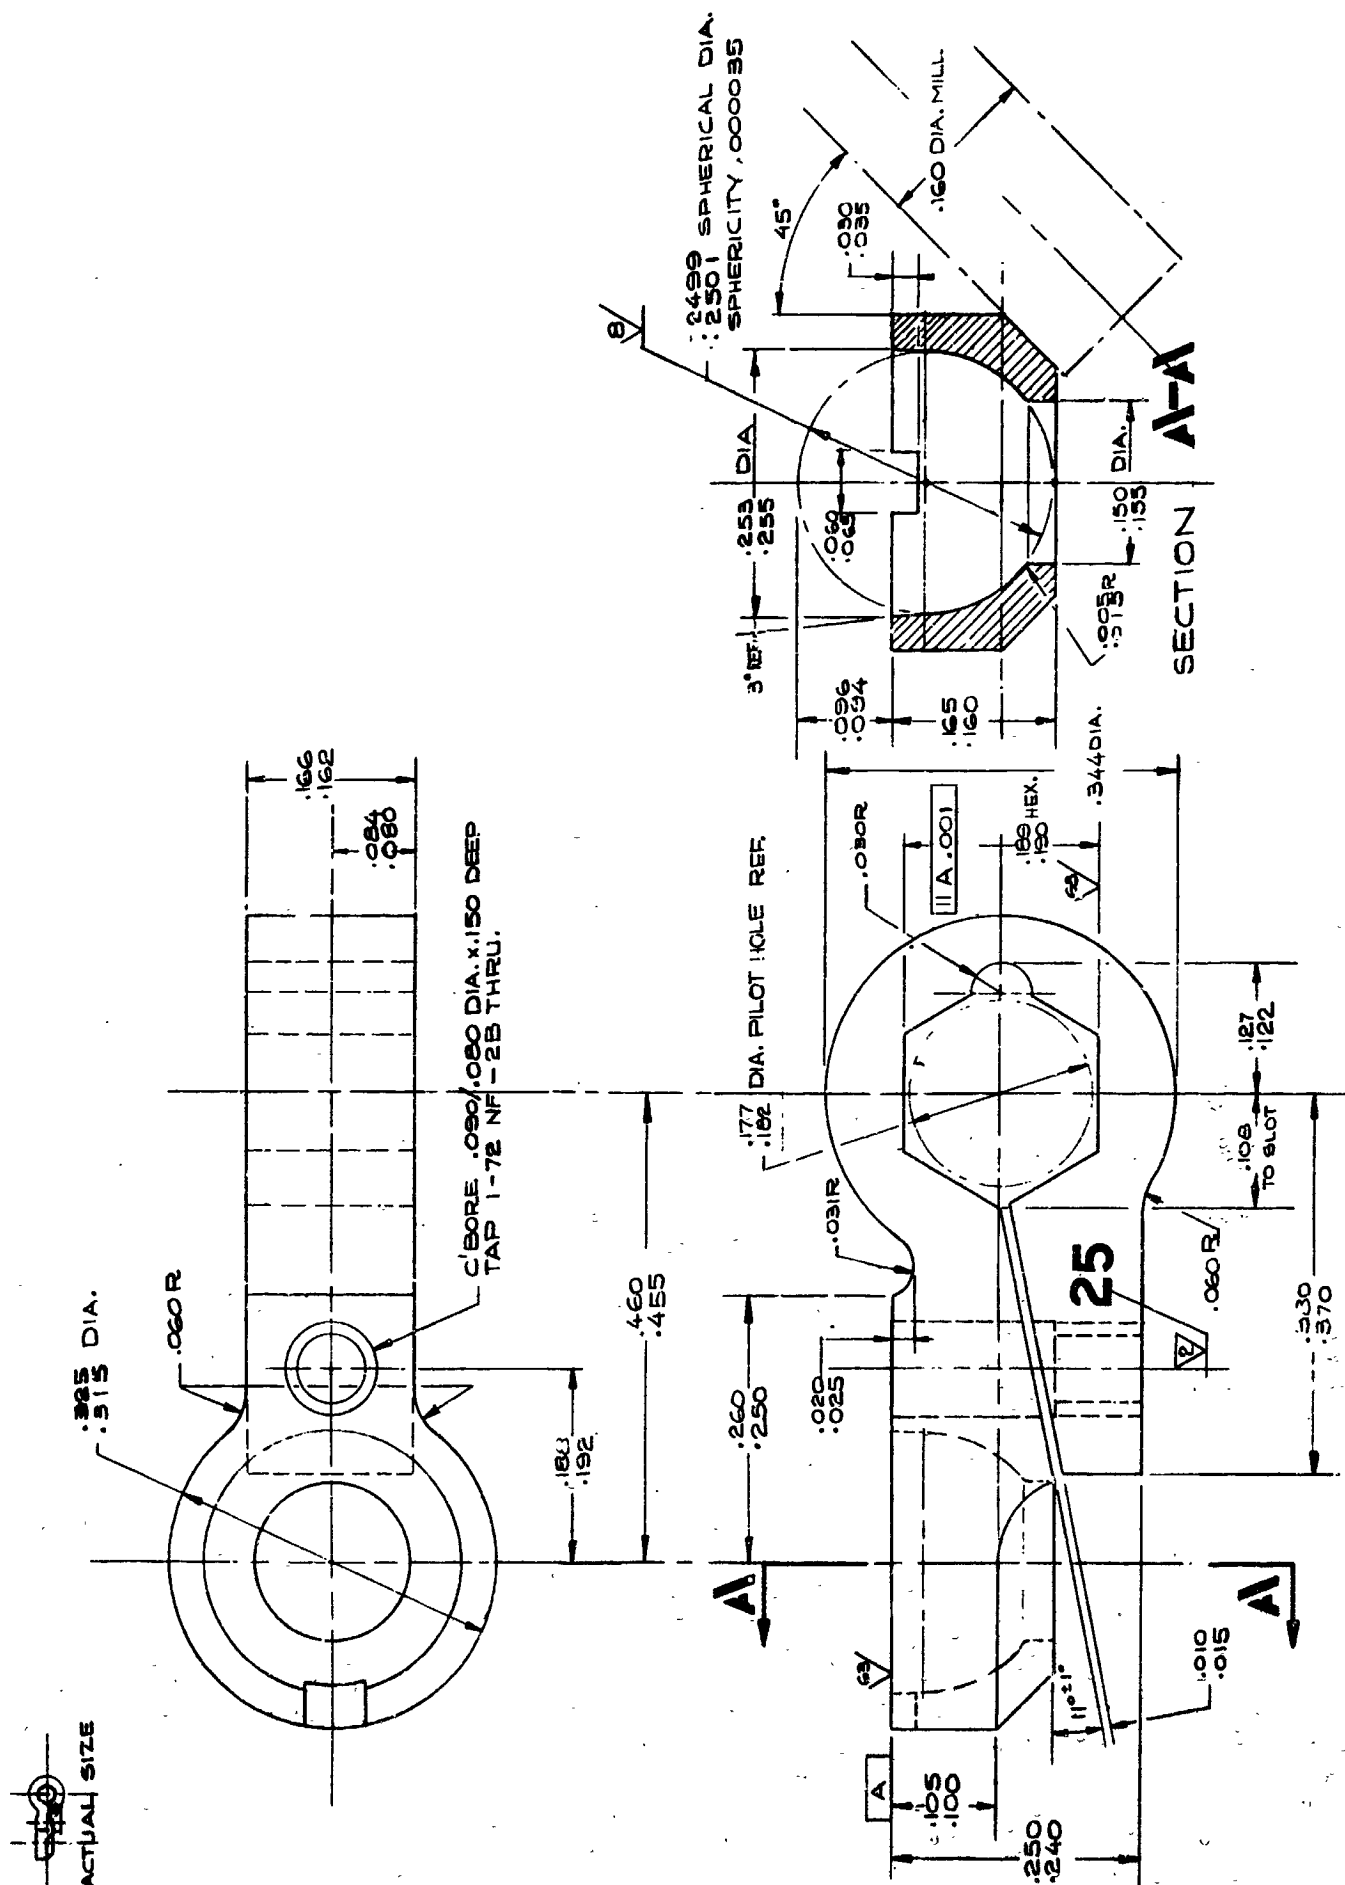
Fig. 2 - O₂ Injector Rocker Arm

2. New oxygen injector poppets are being fabricated to the redesigned configuration shown in Figs. 2 and 3. This design provides approximately three times the contact area of the original design and eliminates the slot in the rocker arm. Both Haynes 6B and L605 parts are being fabricated.

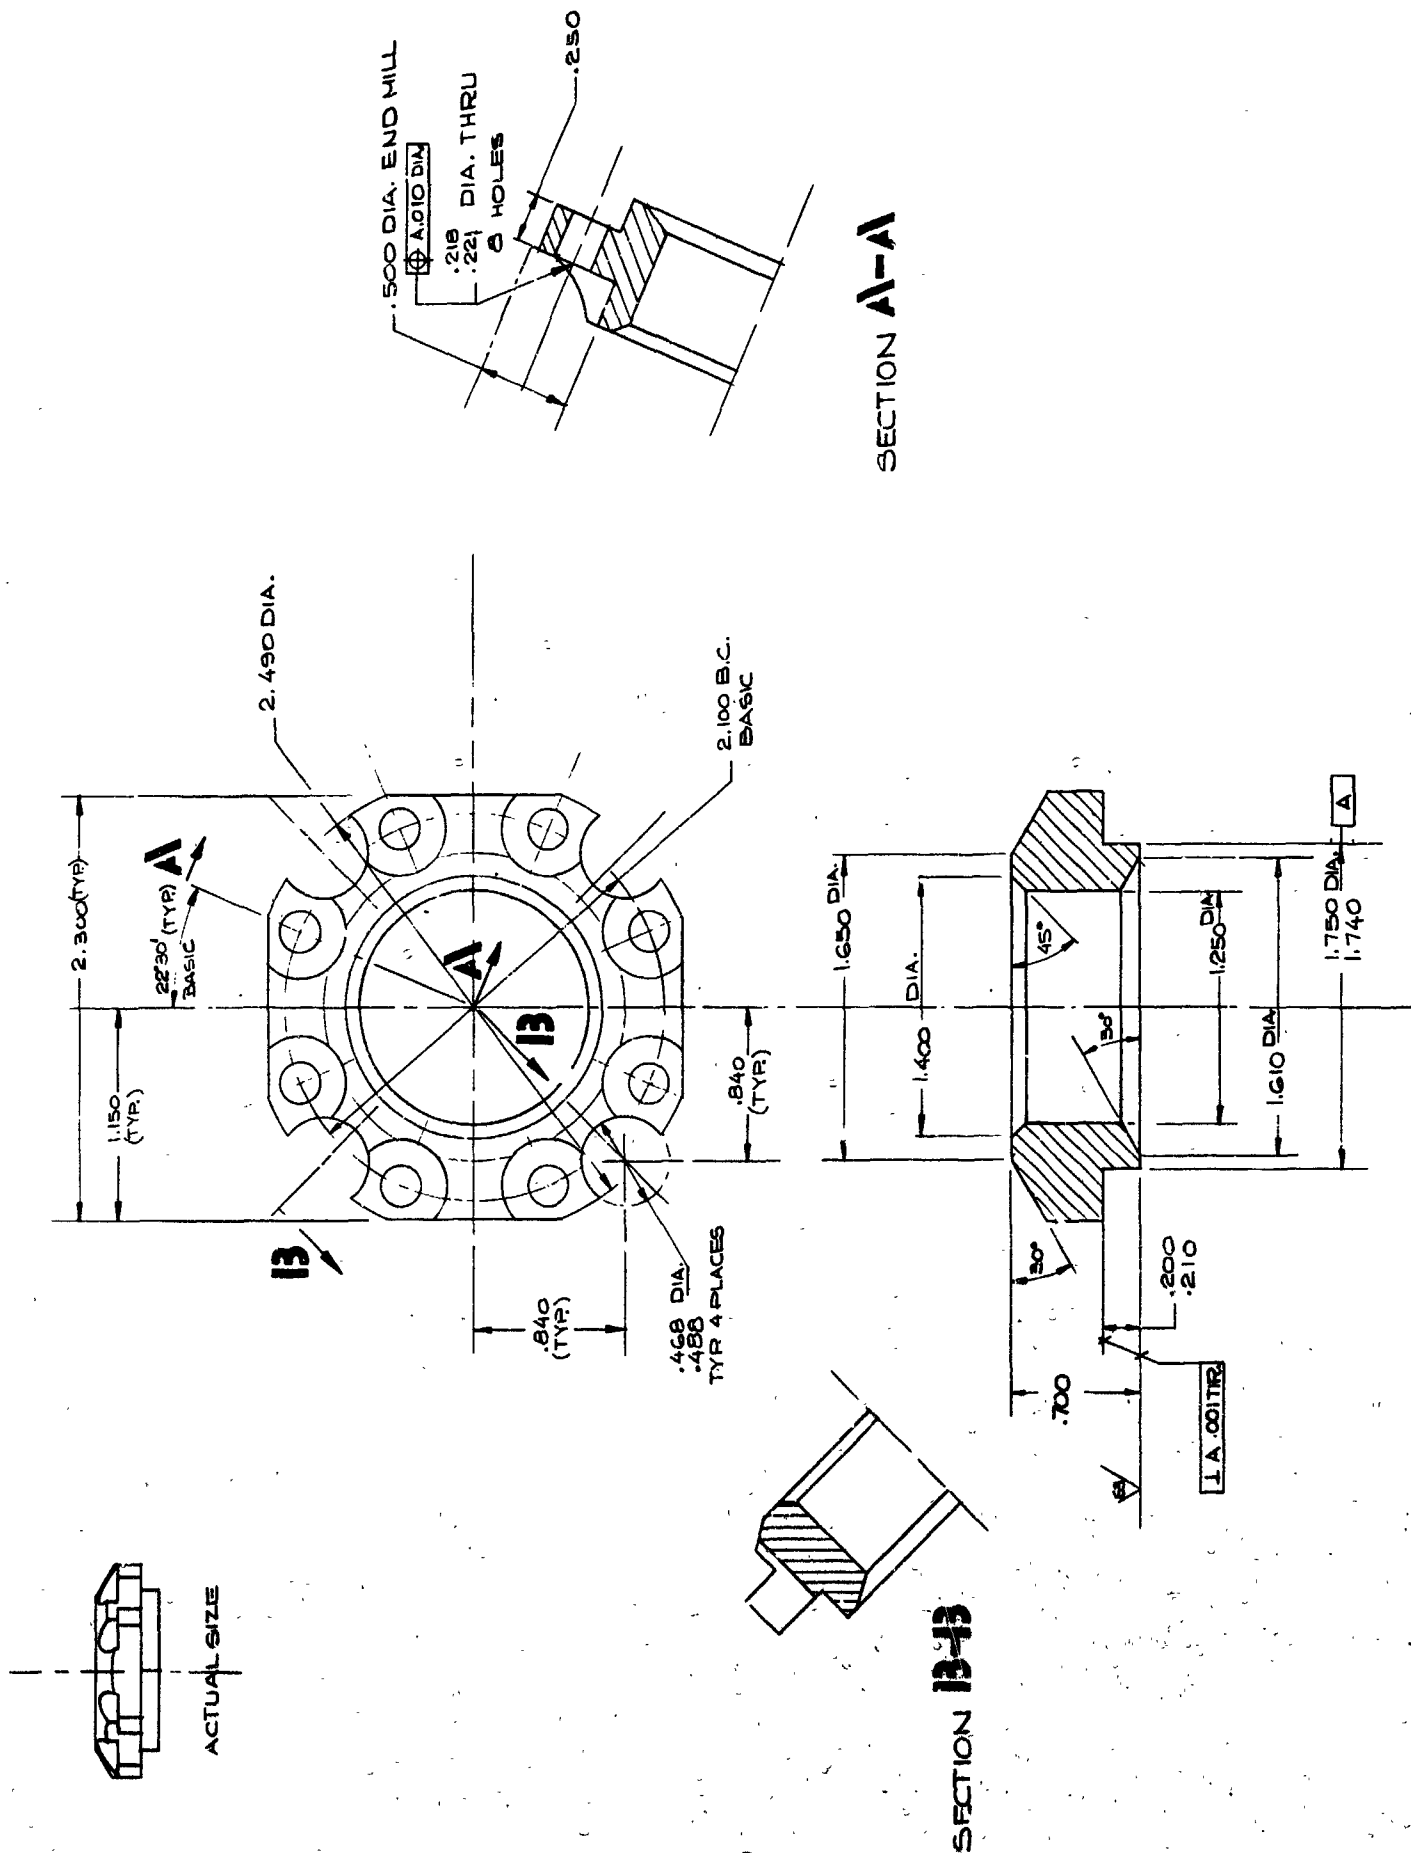
Fig. 4 - Combustion Chamber Retainer

3. A redesigned retainer for the cylinder head insert was fabricated (see Fig. 4). The objective of this design was to increase the reliability of the retainer and reduce the possibility of leakage through the cylinder head insert "K" seal.
